**BAGHDAD POLICE COLLEGE  
BAGHDAD, IRAQ**

**SIGIR PA-06-078.2**

**SIGIR PA-06-079.2**

SUBJECT: Report on Project Assessments of Reconstruction Work Performed Under Task Orders 06 and 29 at the Baghdad Police College, Baghdad, Iraq (Report Numbers SIGIR PA-06-078.2 and PA-06-079.2)

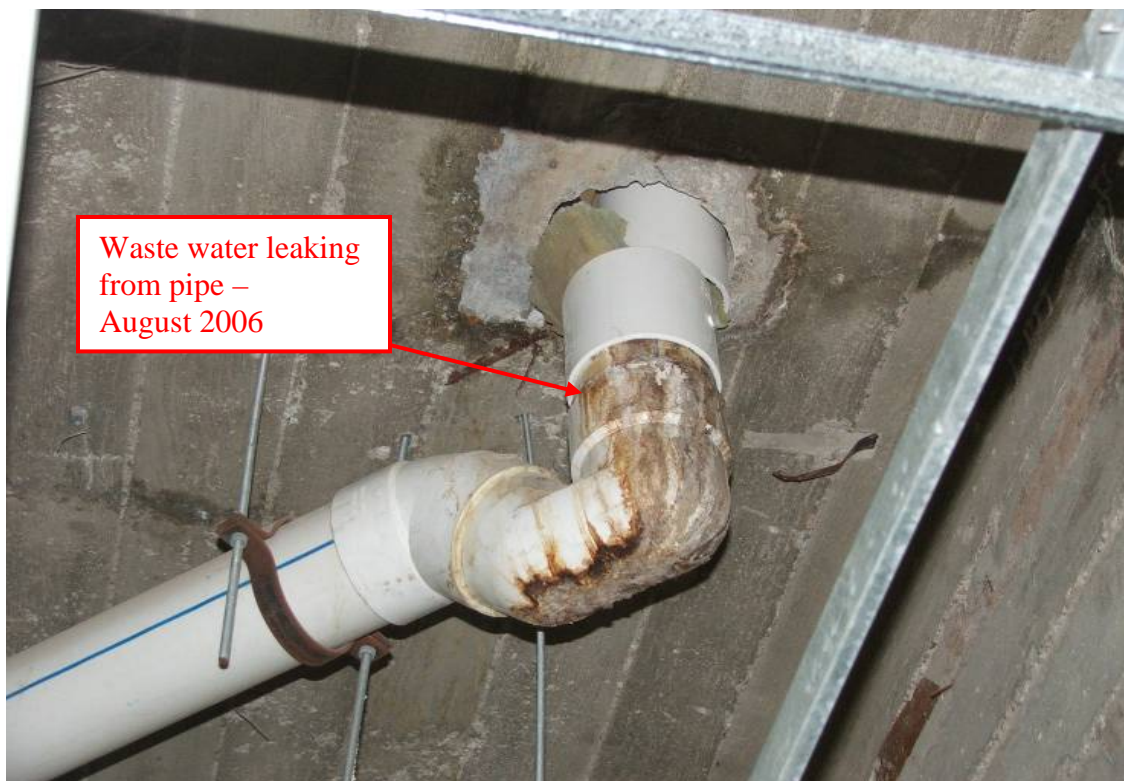
**Site Photo 76. Effect of leaking waste water on plumbing pipes**

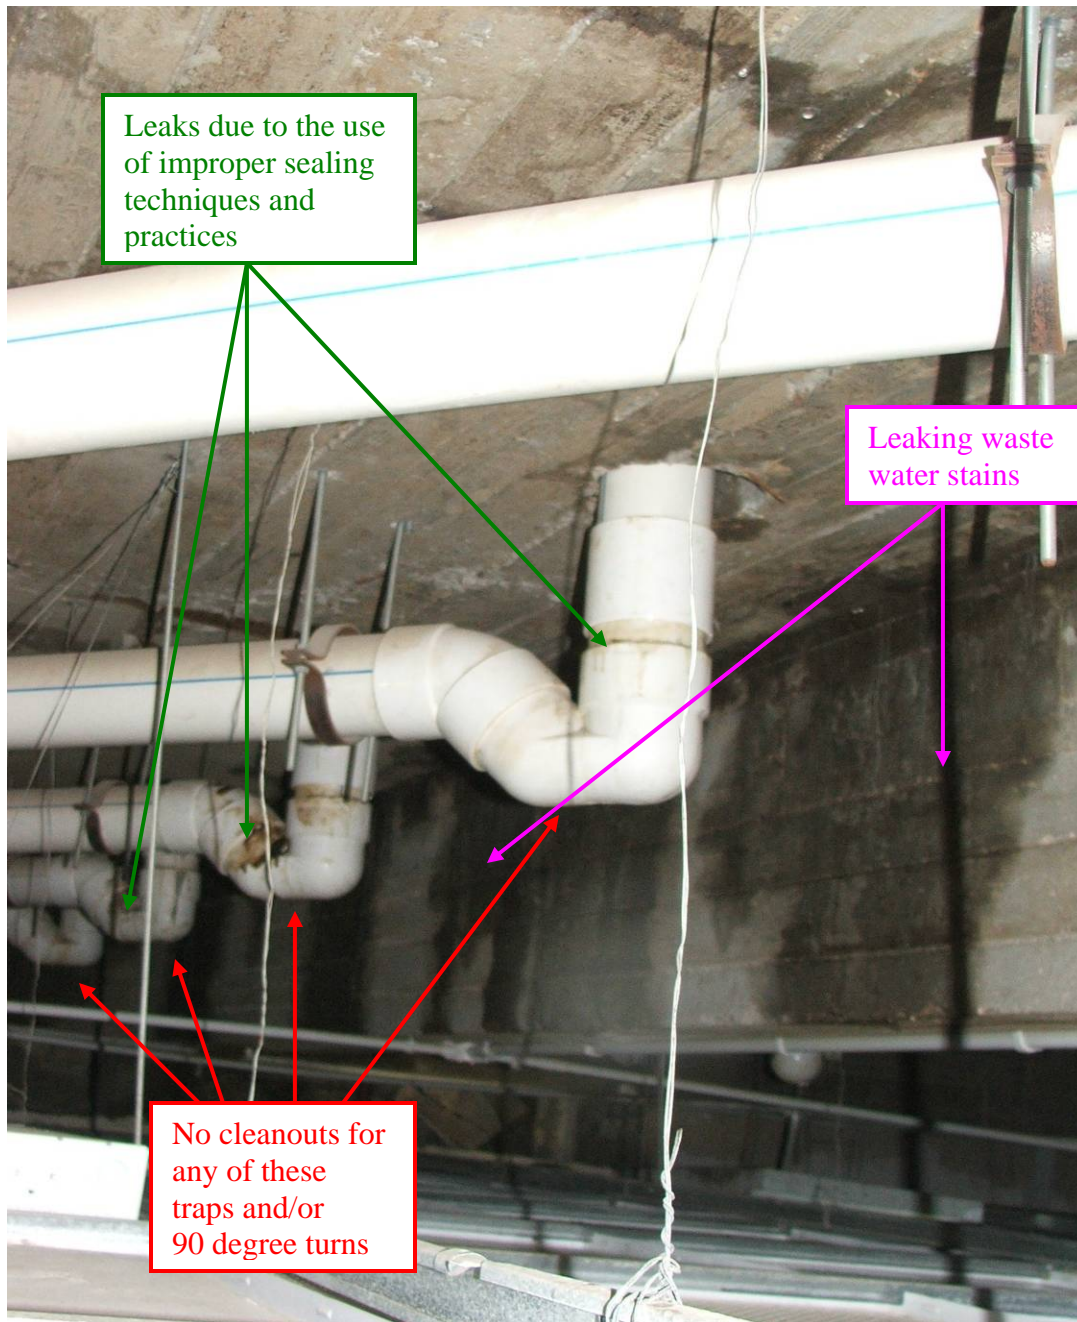
**Site Photo 77. View of plumbing for first floor toilets without cleanouts and proper sealing practices**

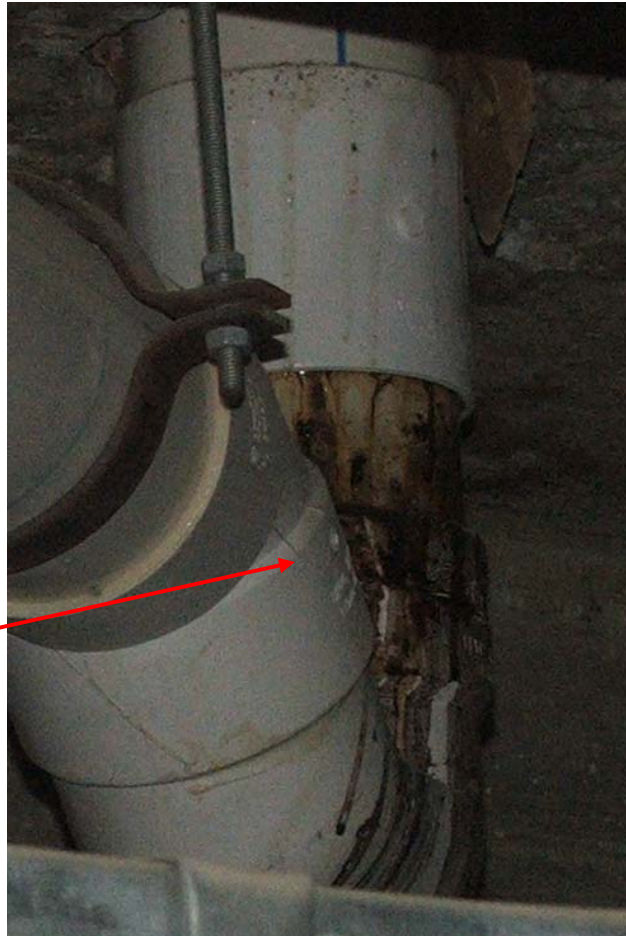
**Site Photo 81. Enlarged view of Site Photo 80**

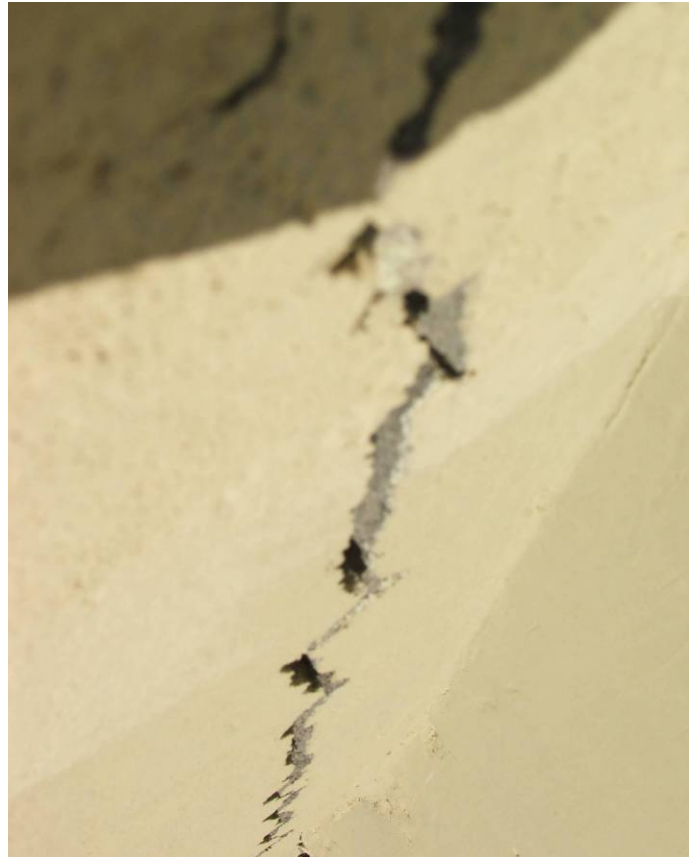
**Site Photo 82. Exterior expansion crack**

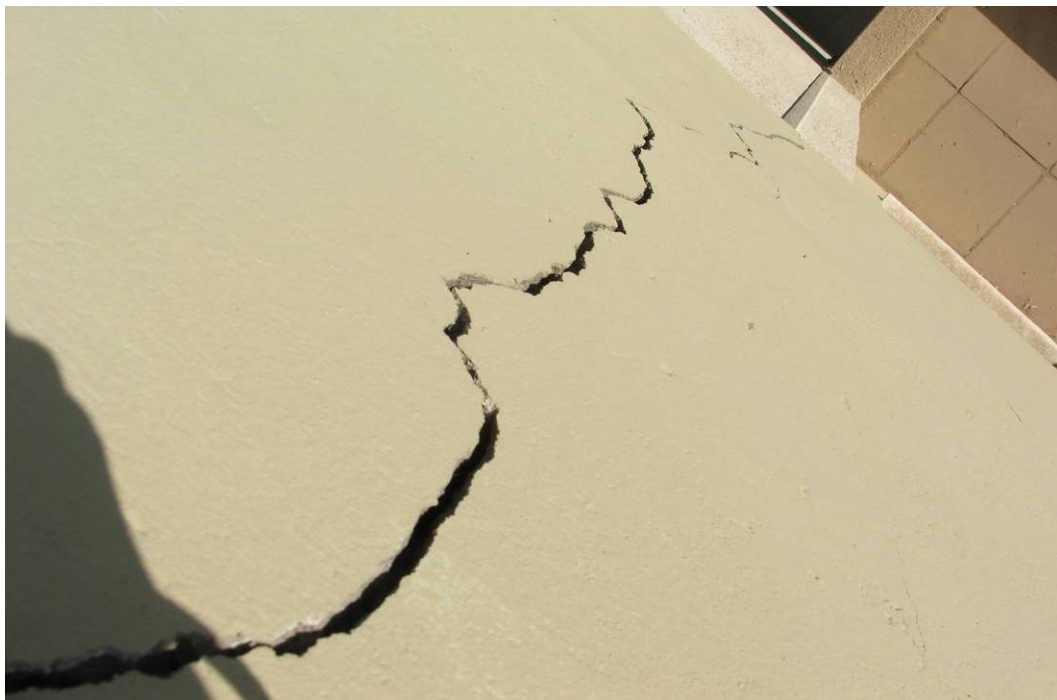
**Site Photo 83. Substantial exterior expansion crack**

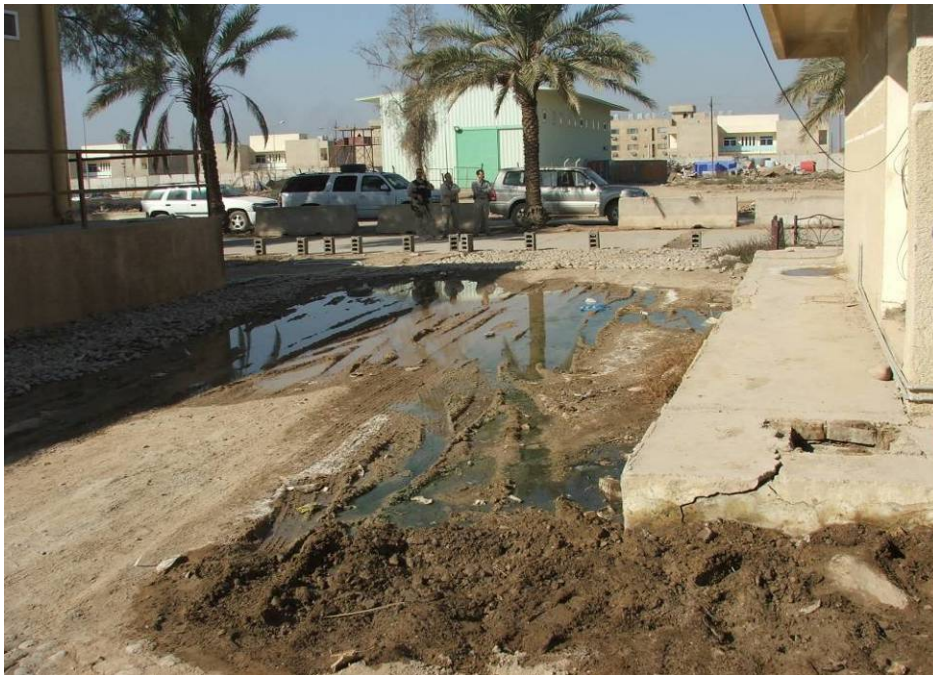
**Site Photo 90. Significant standing sewer water outside the BPC security office**

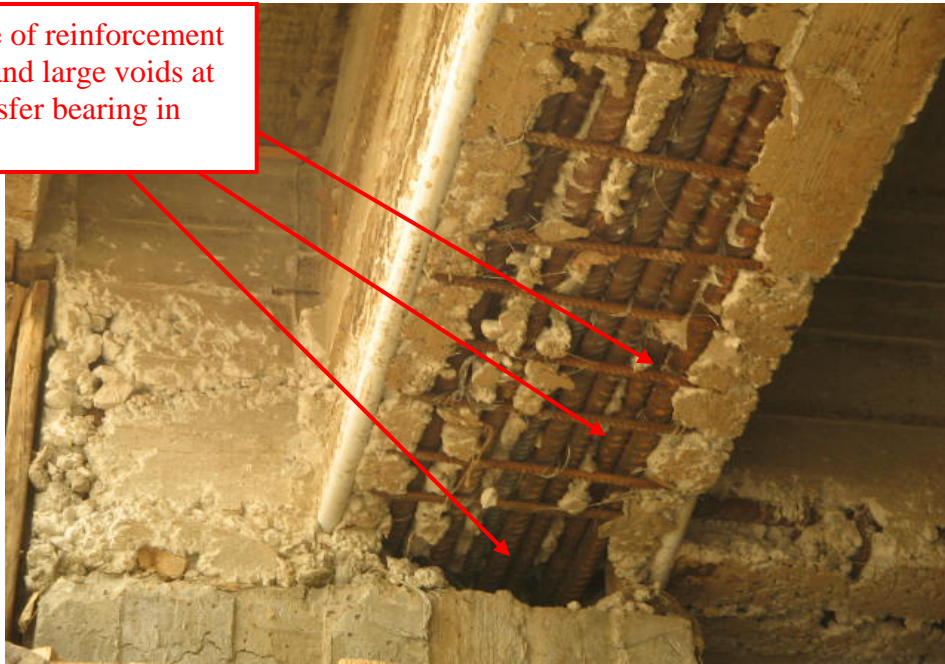
Evidence of reinforcement bar rust and large voids at load transfer bearing in column

**Site Photo 91. Construction deficiencies within the central laundry facility**

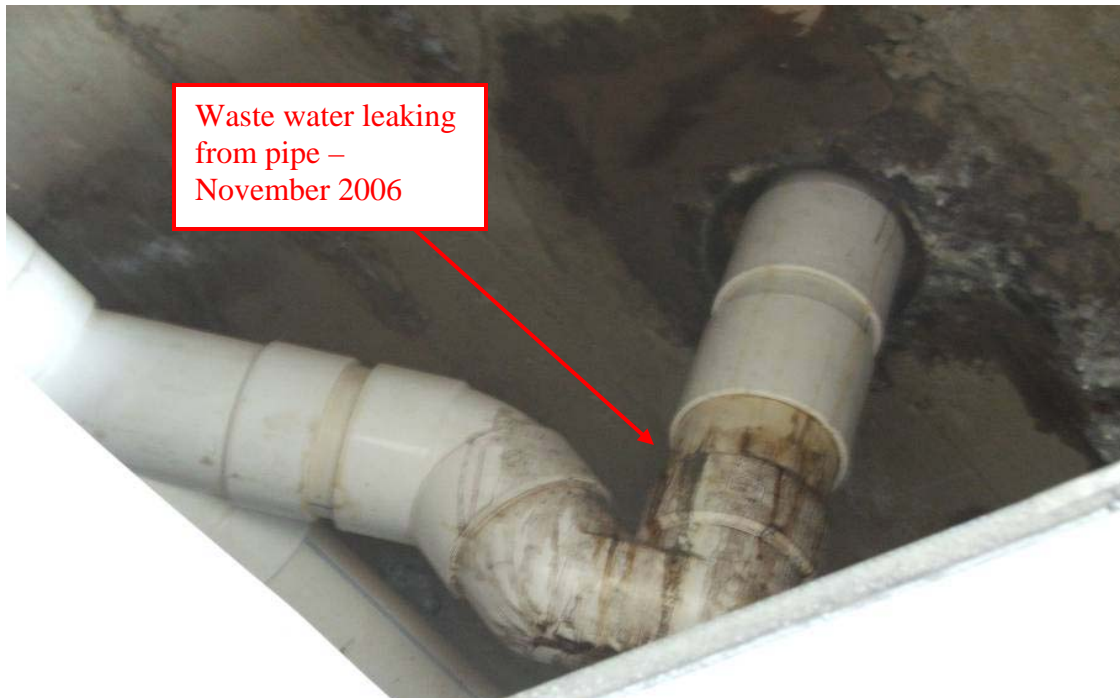
during this site visit as we did in our earlier site visits, such as water leaking from the ceiling. In addition, we noticed leaking waste water in the same location on the pipes (Site Photos 95 and 96). It is apparent that the subcontractor did not properly connect the pipes together, which allowed waste water to drain on the outside of the pipes.

**Site Photo 95. Effect of leaking waste water on plumbing pipes**

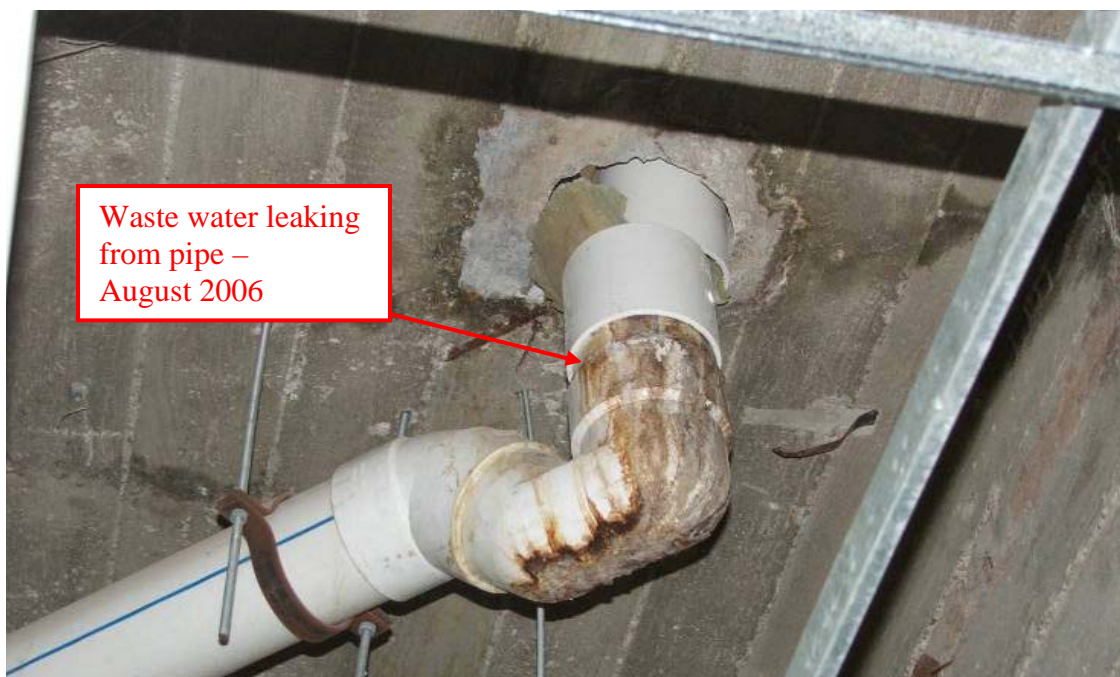
**Site Photo 96. Effect of leaking waste water on plumbing pipes**

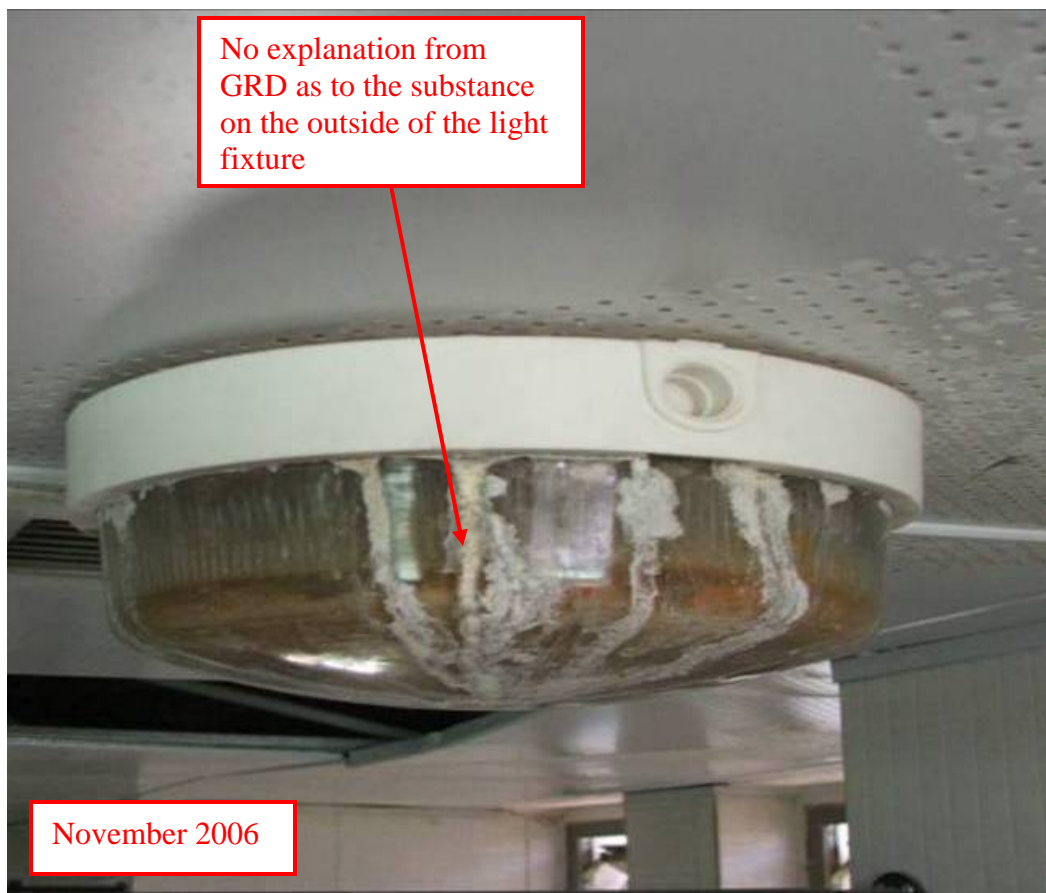
**Site Photo 97. Urine-filled light fixture in cadet barracks bathroom after rework**

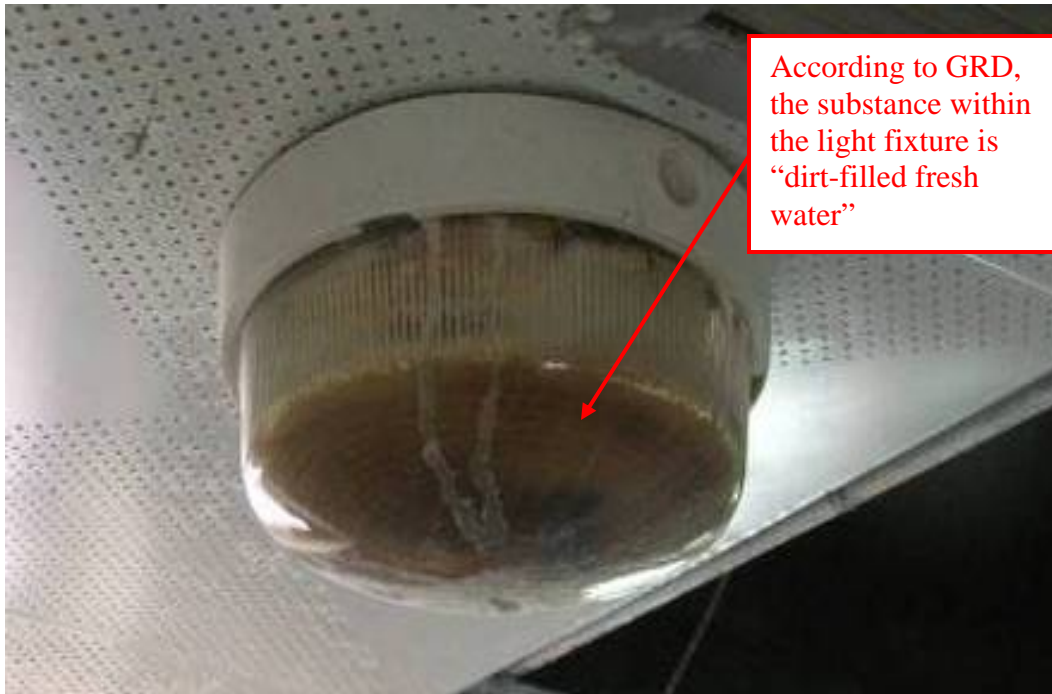
**Site Photo 99. Light fixture with the cadet barracks bathroom (November 2006)**

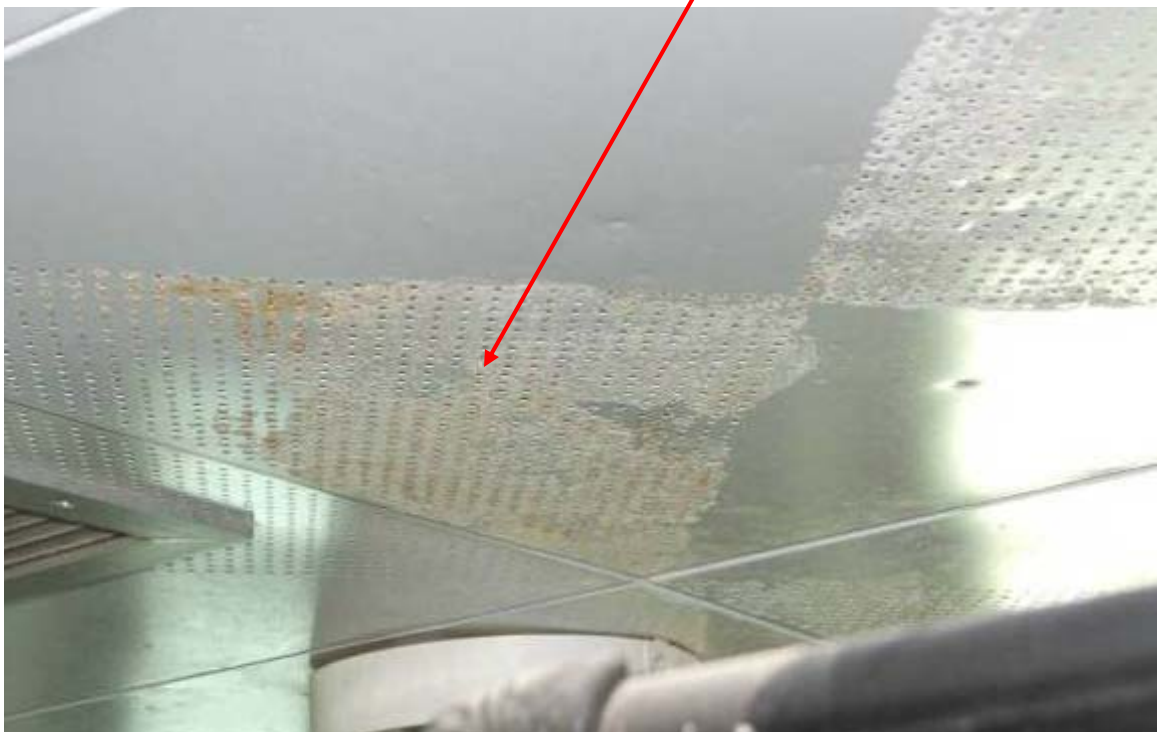
**Site Photo 102. Enlarged view of Site Photo 101**

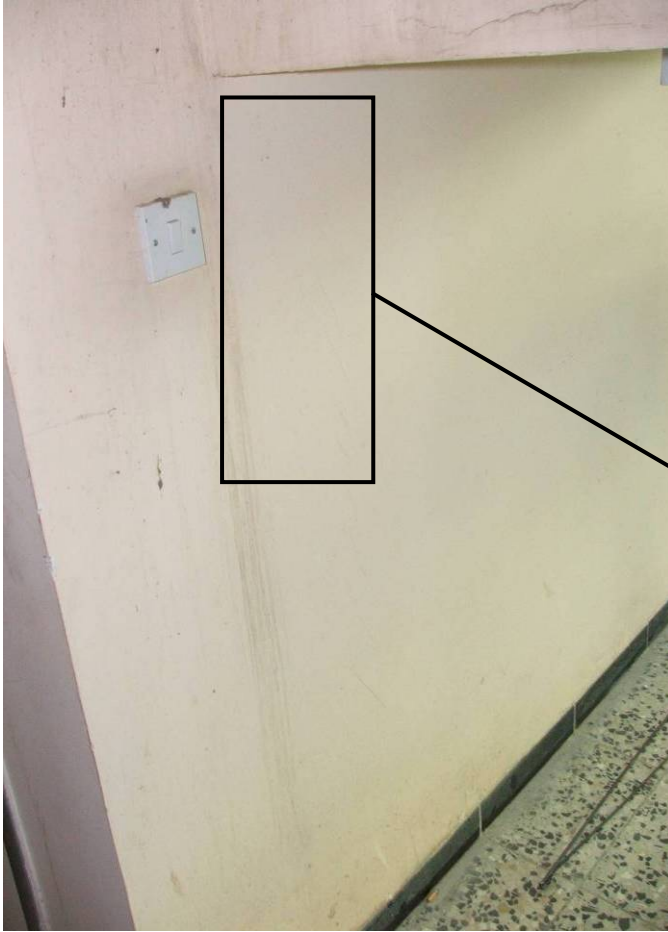
**Site Photo 122. Stress cracks underneath staircase**

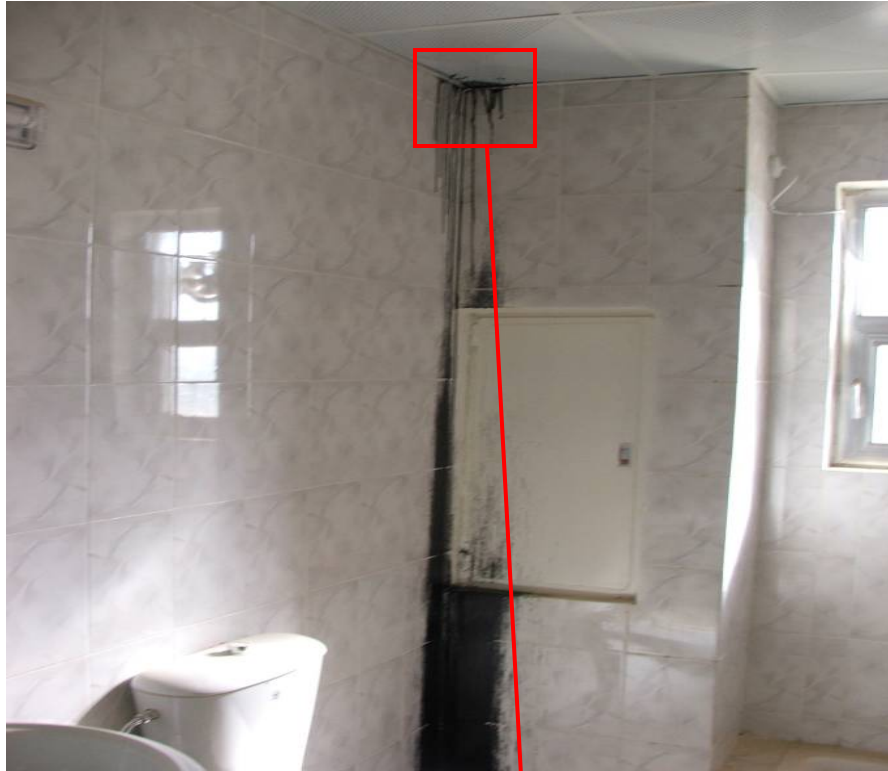
**Site Photo 129. Ceiling and wall damage in bathroom**

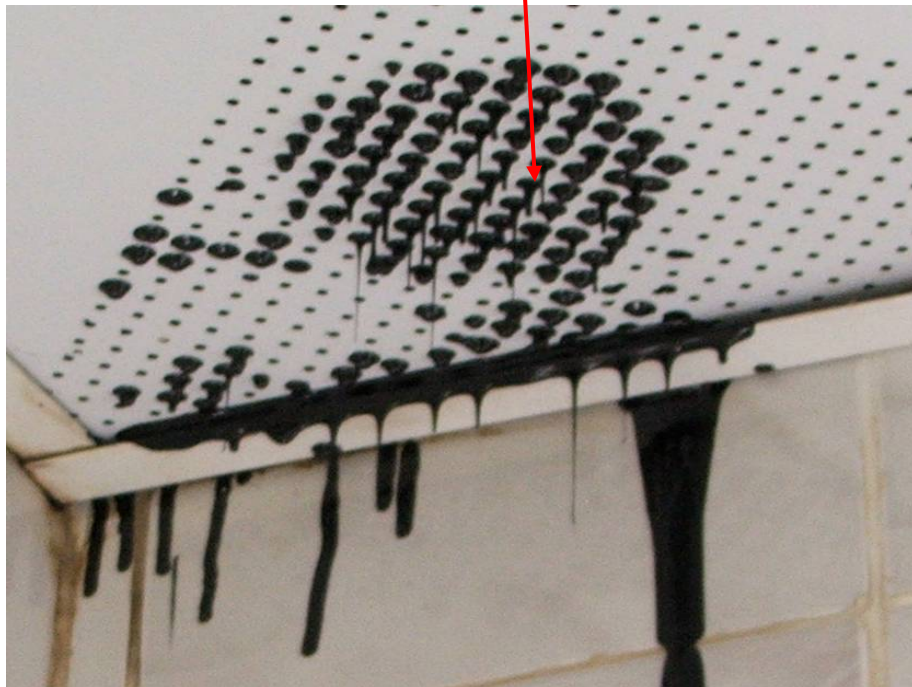
**Site Photo 130. Enlarged view of ceiling damage seen in Site Photo 129**

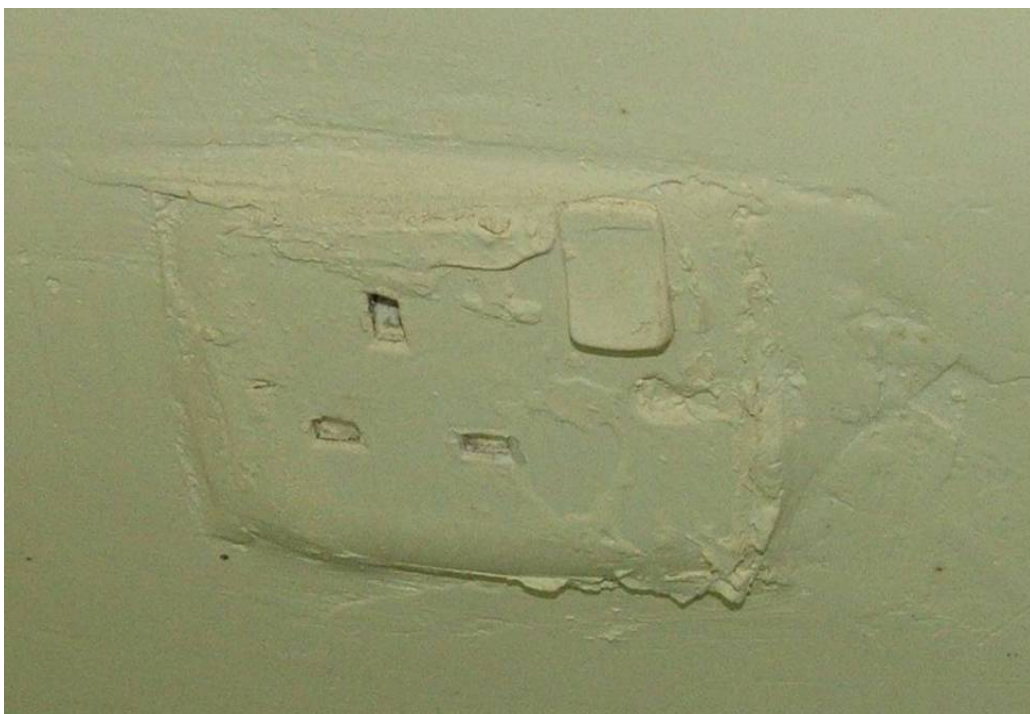
**Site Photo 131. Electrical outlet covered with mortar and paint**

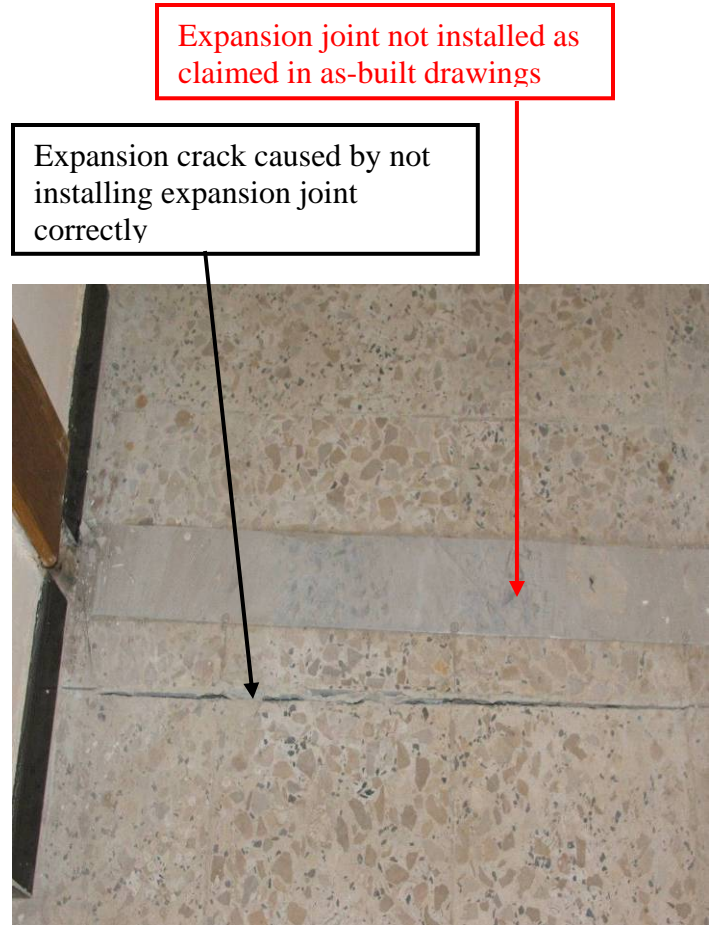
**Site Photo 132. Interior expansion crack**

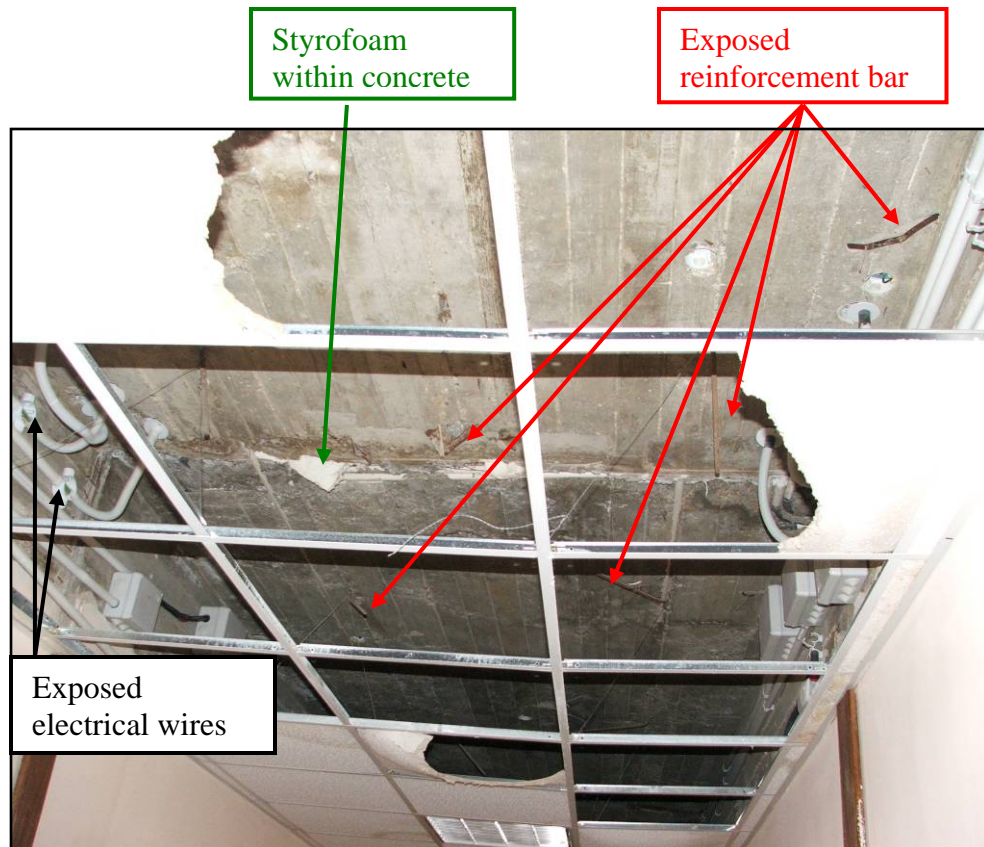
The ground floor consisted of single occupancy bedrooms with private bathrooms. We identified tar damage in the bathrooms from tar leaking from the roof down to the ground floor. In addition, we identified exposed reinforcement bar, Styrofoam within the concrete formwork, and exposed electrical wires (Site Photo 137). Since neither building has generator power or water and sewer connections, we were unable to determine if the electrical fixtures or the plumbing systems worked correctly.

**Site Photo 137. Poor quality construction work in the language instructors' barracks**

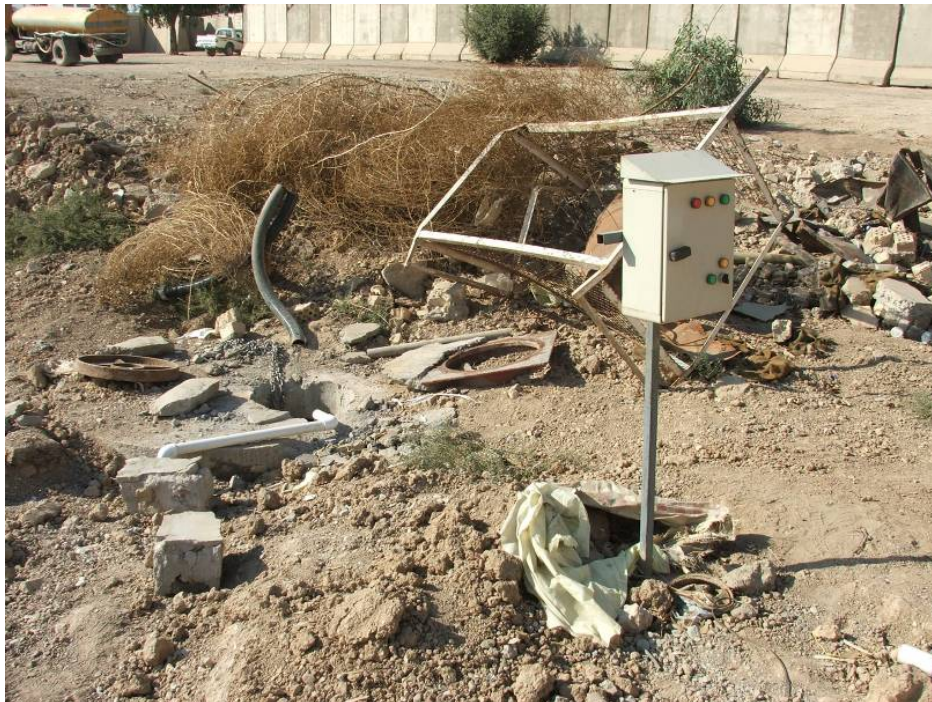
**Site Photo 160. Original single pump station installed by Parsons but never connected to power**

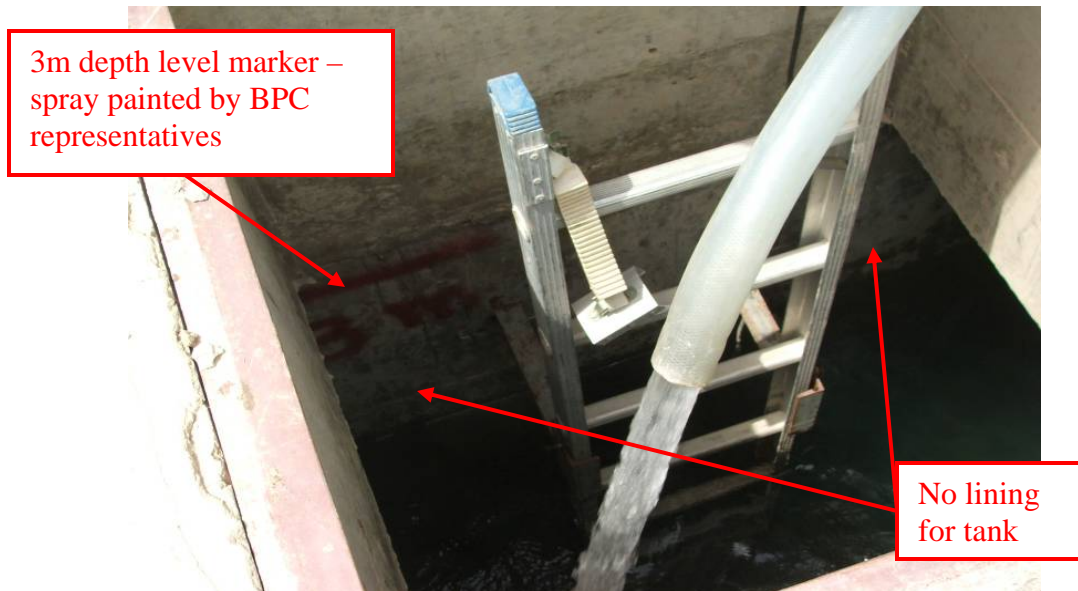
**Site Photo 173. Water trucked into the BPC is being poured into the unlined water storage tank**

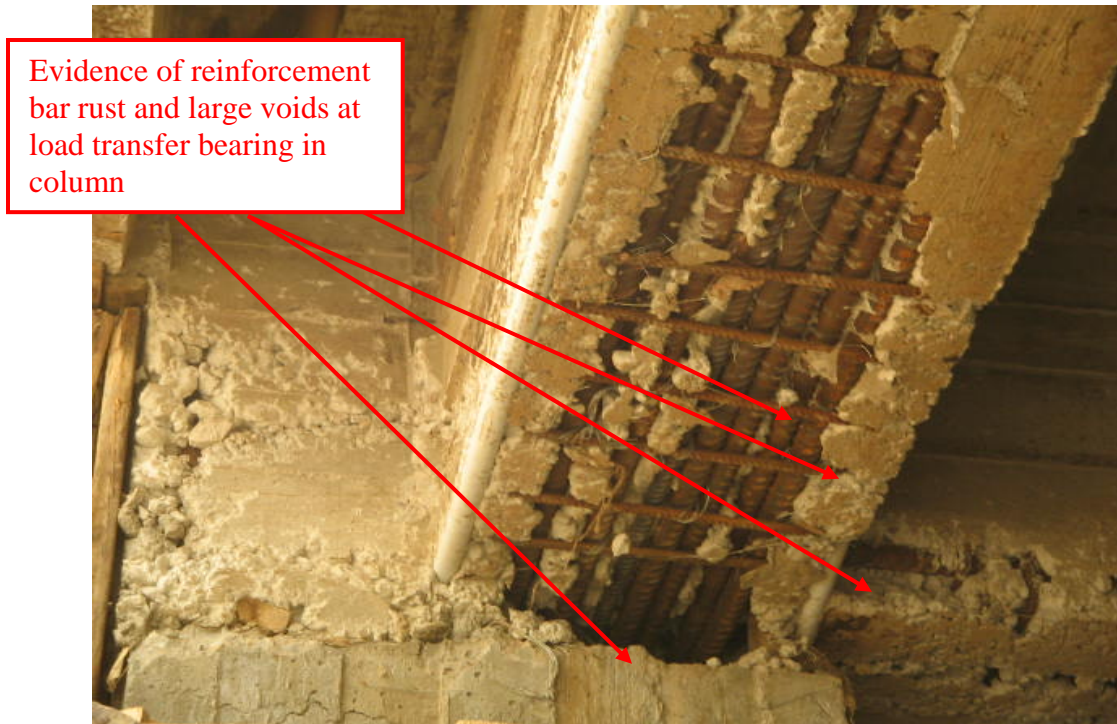
**Site Photo 178. Construction deficiencies within the central laundry facility**

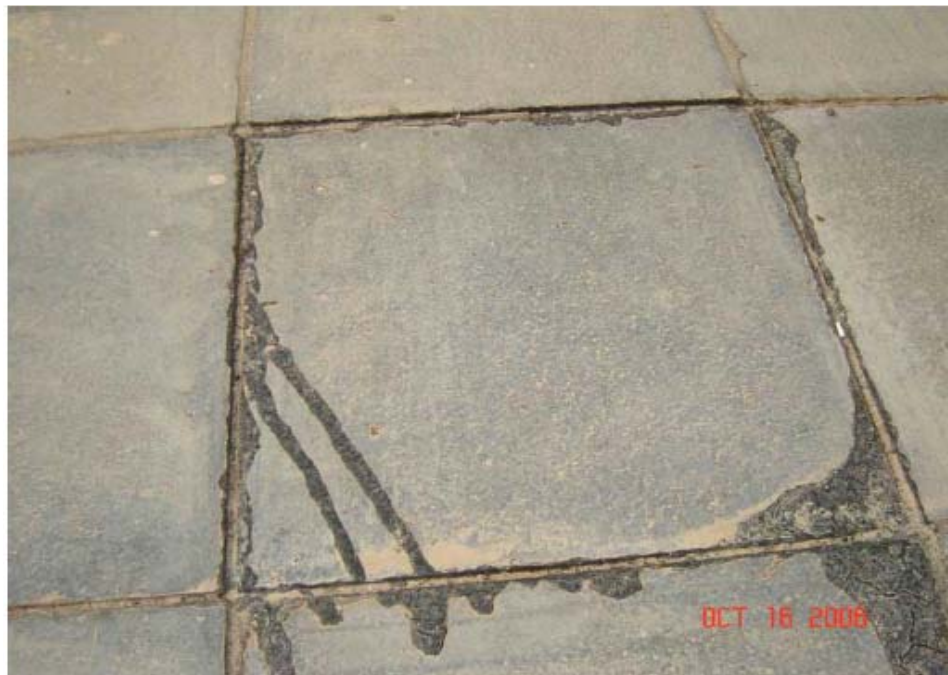
**Site Photo 202. Example of poor mastic work on the roof**

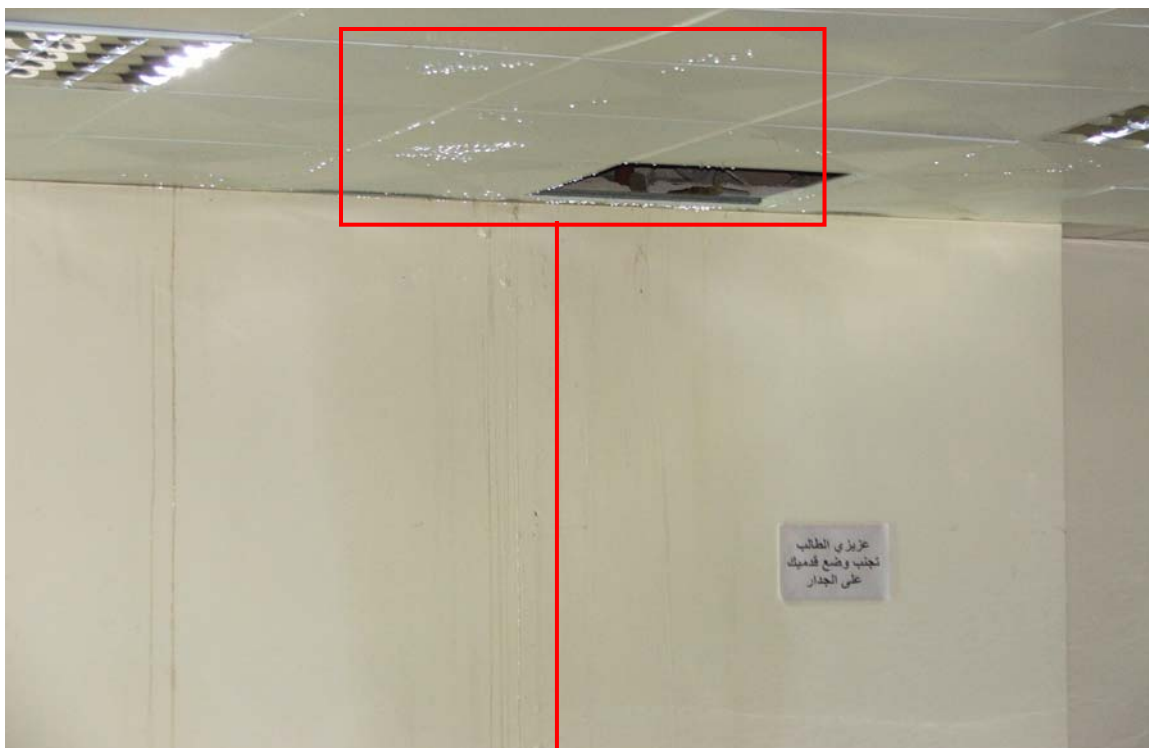
**Site Photo 206. Water leaking from ceiling of cadet barracks**

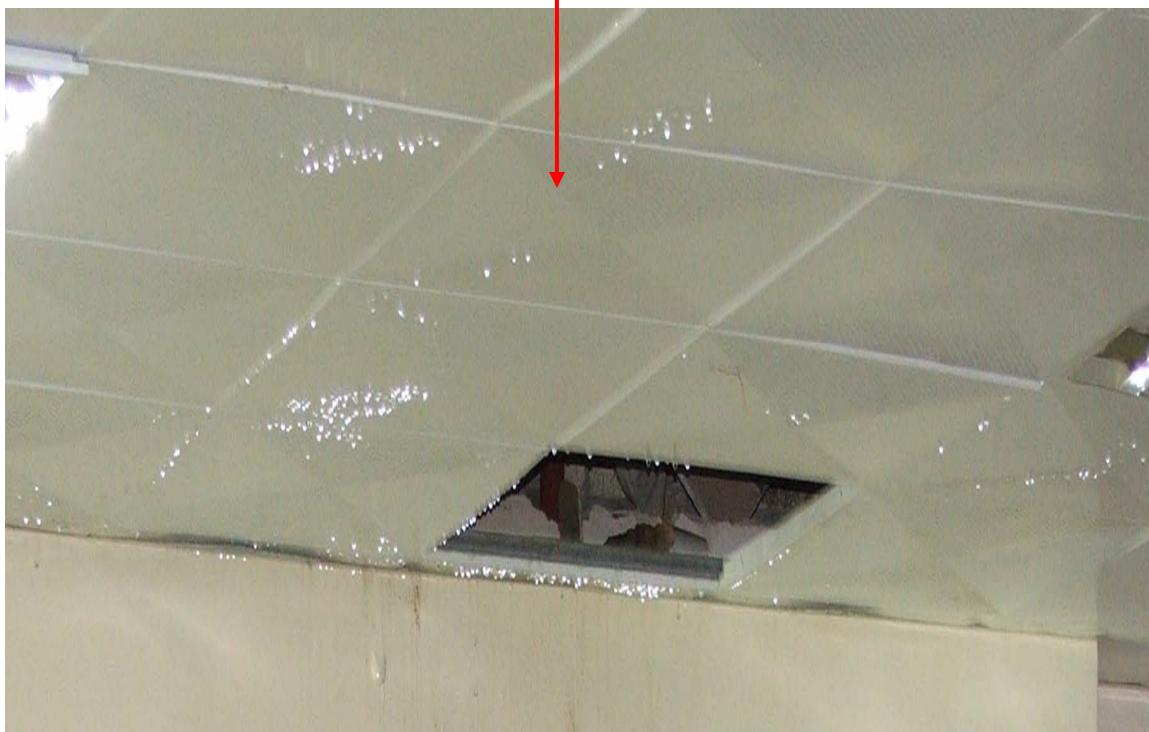
**Site Photo 207. Close-up view of the water leaking from the ceiling of Site Photo 206**

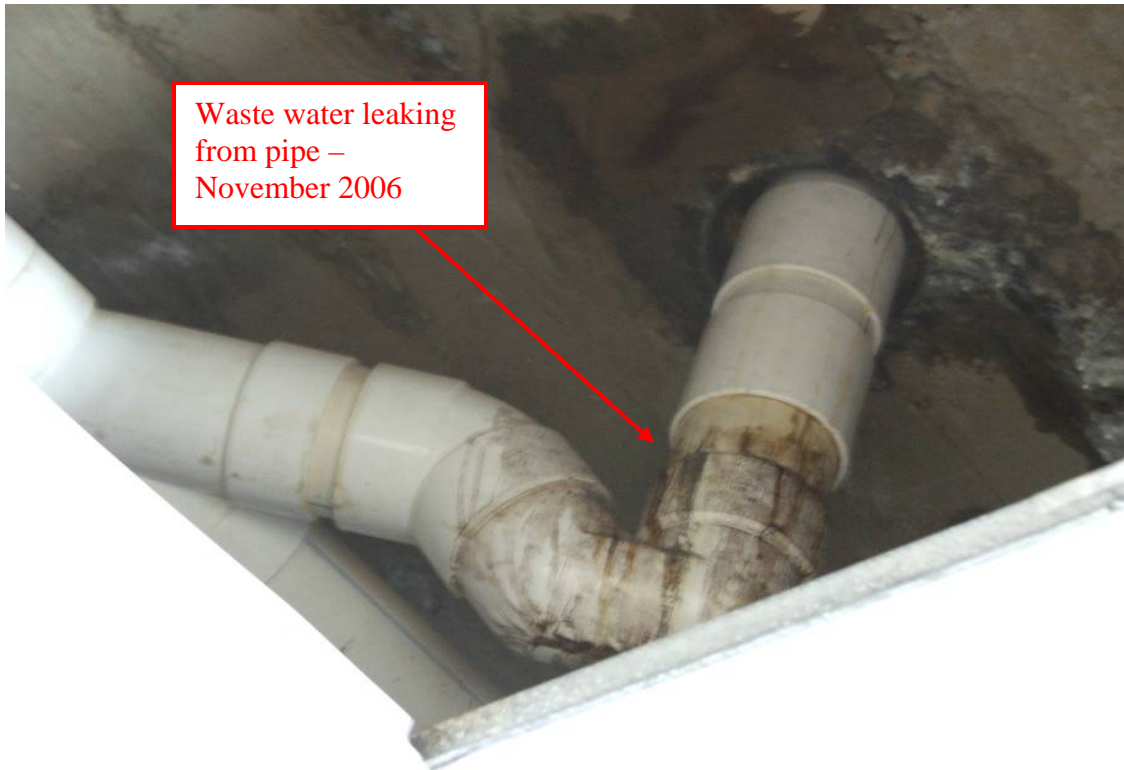
**Site Photo 208. Effect of leaking waste water on plumbing pipes**

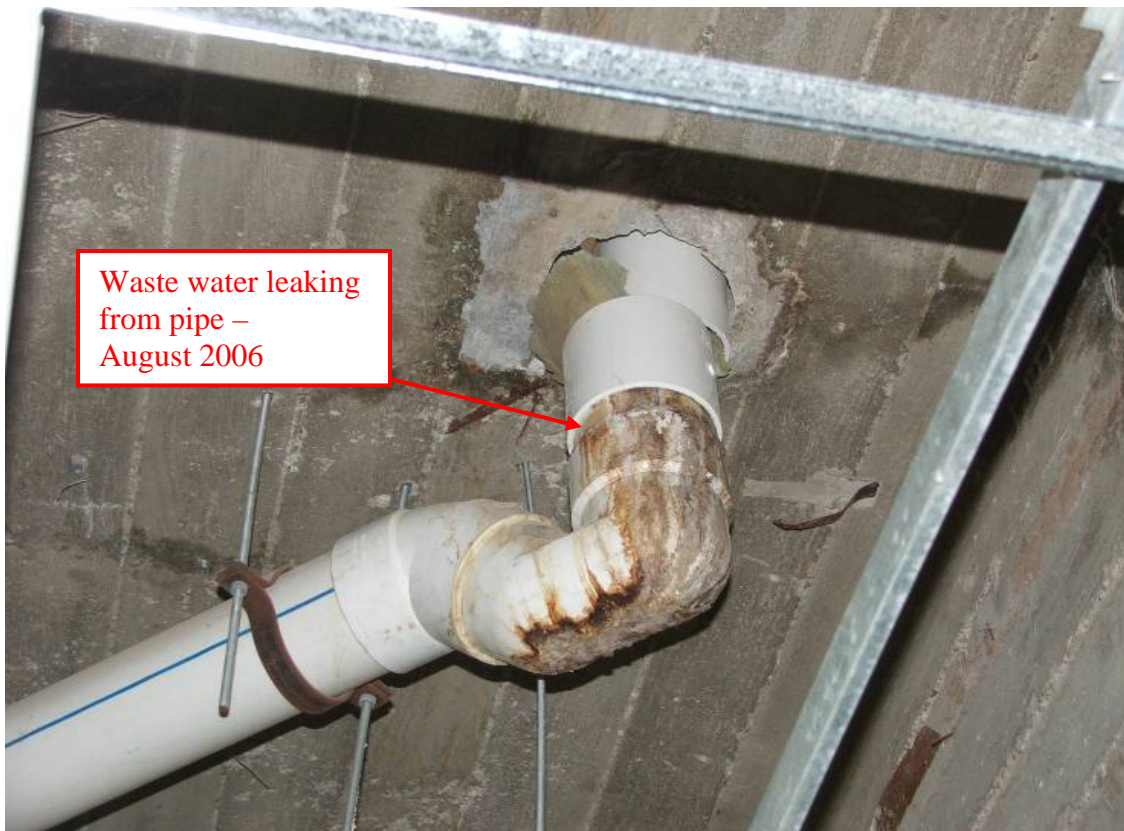
**Site Photo 209. Effect of leaking waste water on plumbing pipes**

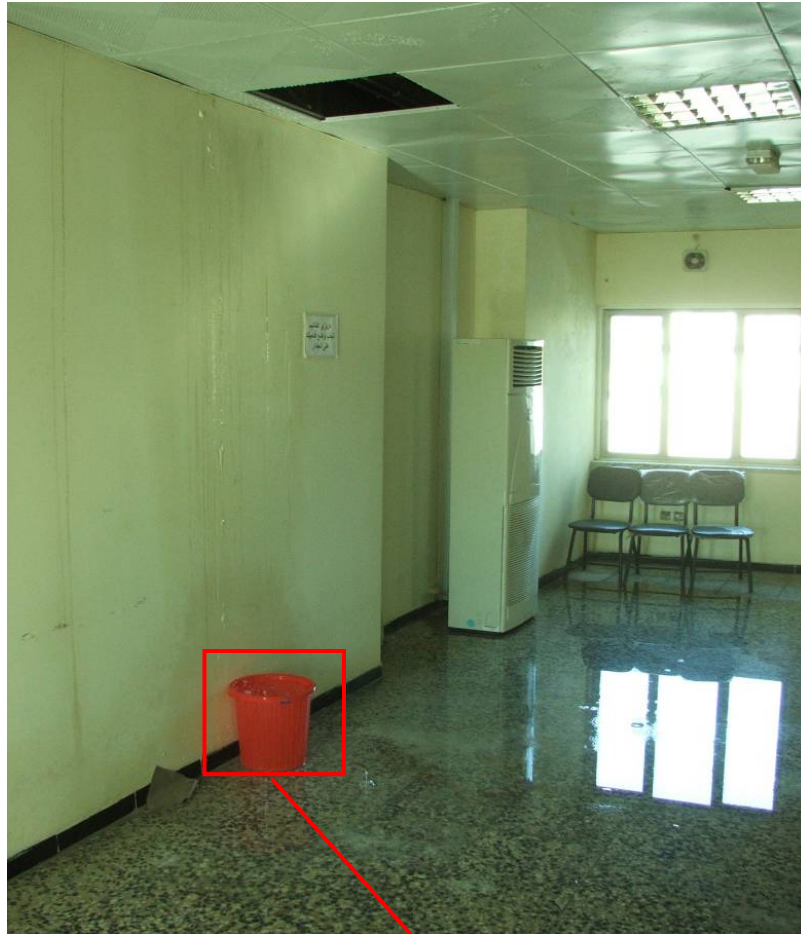
**Site Photo 210. Total accumulation of leaking water in cadet barracks**

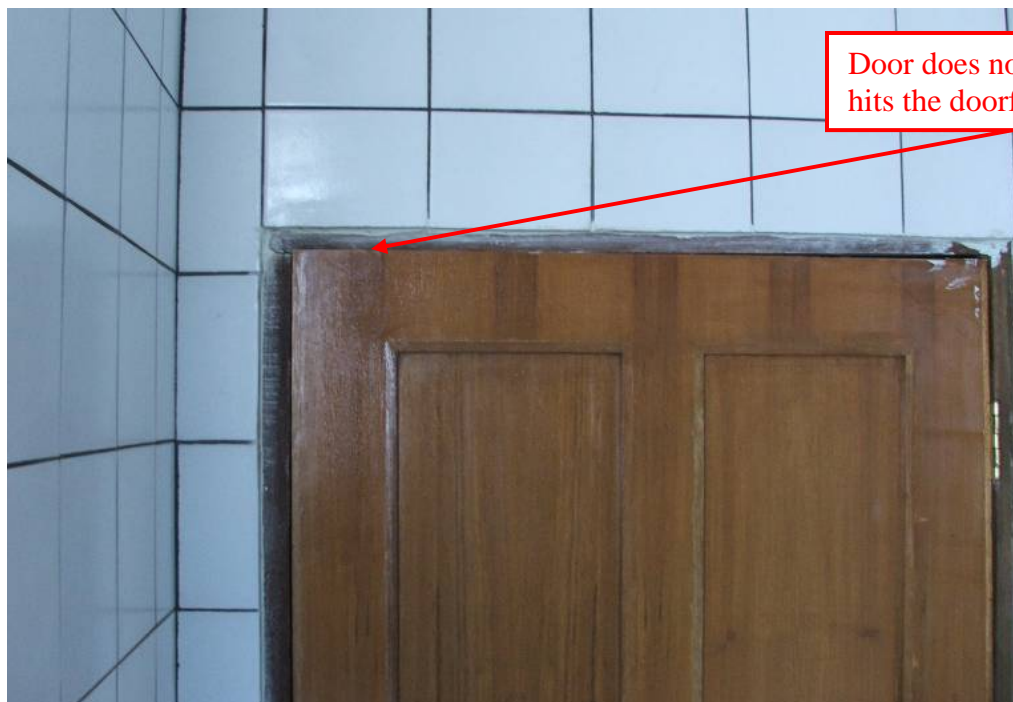
Door does not shut – it  
hits the doorframe
